**PUGET SOUND  
NAVAL SHIPYARD  
BREMERTON  
FLEET MOORINGS  
UNDERWATER  
INSPECTION  
REPORT**

**OCTOBER 1983**

OCEAN ENGINEERING  
AND CONSTRUCTION PROJECT OFFICE  
CHESAPEAKE DIVISION  
NAVAL FACILITIES ENGINEERING COMMAND  
WASHINGTON, D.C. 20374

FPO-1-83 (38)

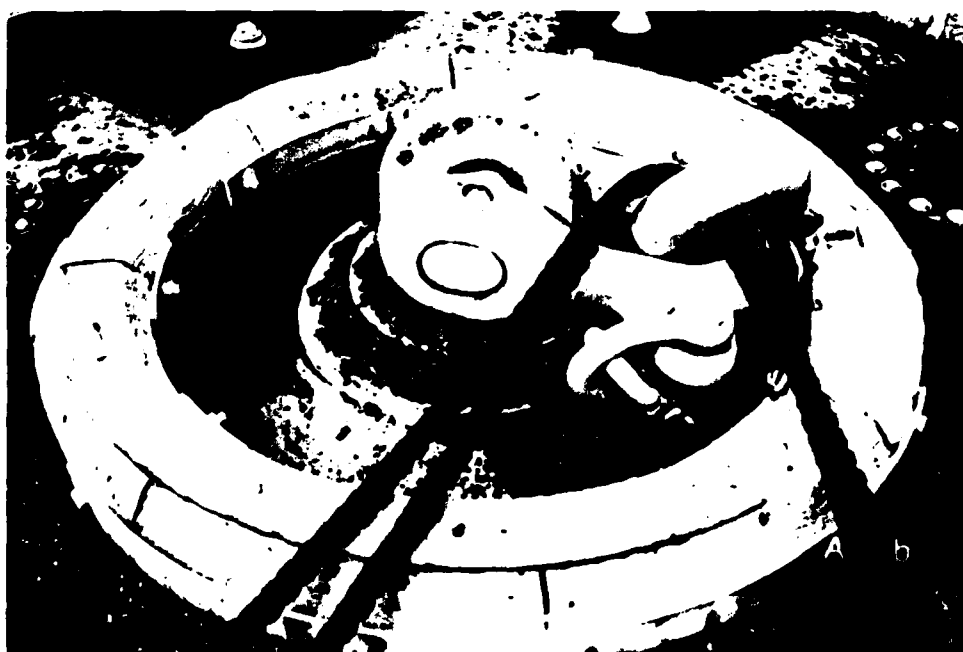
This is a 12-foot-diameter peg-top buoy with a 2 3/4-inch-thick tension bar and 4 feet of freeboard. The buoy was recently refurbished and is in good condition. The chaffing rails have metal plates attached.

Mooring A-12 – Top Jewelry in Good Condition

- o Due to undersized (2 1/2-inch) riser chain, mooring A-12 should be reclassified as a Class B mooring.
- o Due to undersized (2 1/4-inch) riser chain, mooring A-13 should be reclassified as a Class C mooring.

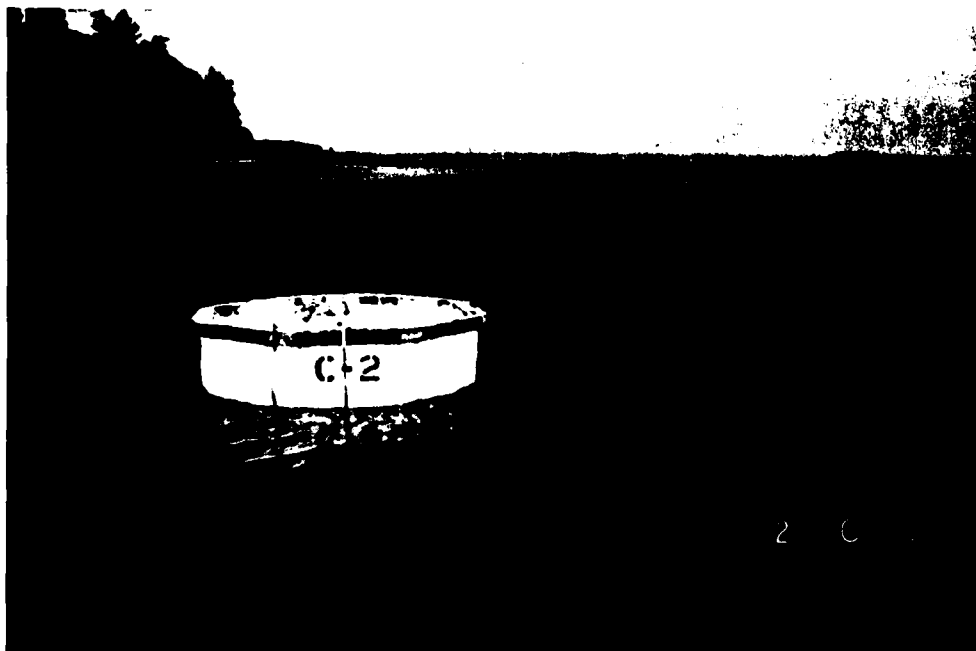
This is a 12 by 6-foot drum type buoy with a hawsepipe. The buoy is newly painted and has 27 inches of freeboard. This relatively short freeboard is probably due to the weight of 315 feet of chain in the water column. One side has a large dent in it but shows no loss of structural integrity. There is medium growth at the waterline and the bottom of the buoy is in good condition.

**Mooring C-2 – Low Freeboard but Good Condition**

The mooring is satisfactory for fleet mooring use and in good condition.

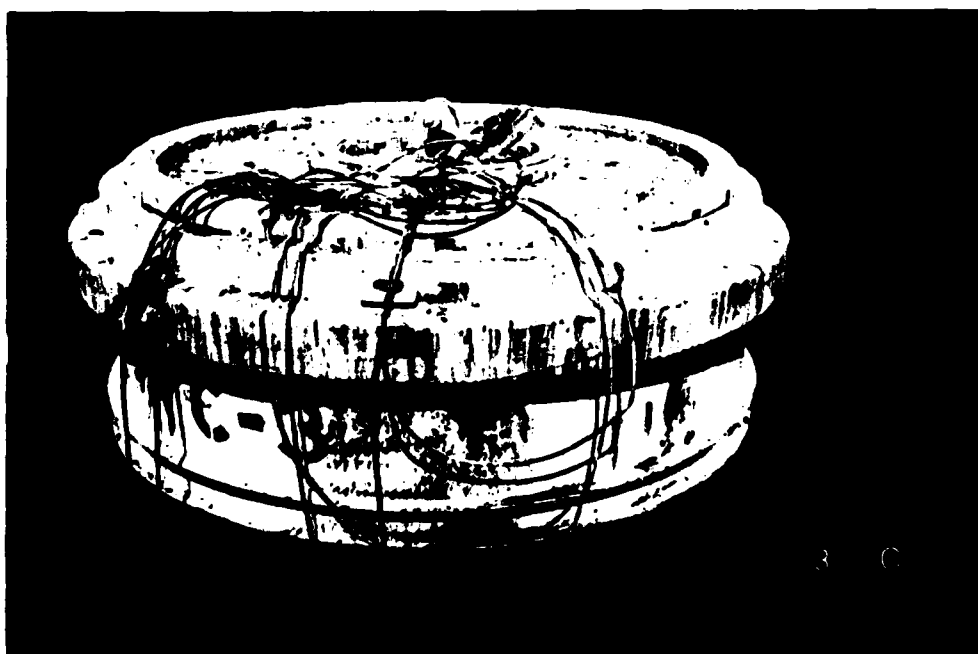
This is a 12 by 9 1/2-foot peg-top with a 2 1/2-inch-thick tension bar and 5 feet of freeboard. A large amount of 3/4-inch wire rope was tangled in the top jewelry and hanging over the side. A small hole was found on a top seam of the buoy. The buoy bottom is in good condition.

**Tangled Wire Rope Atop Mooring C-3**

At the next scheduled repair, the hole in the buoy should be repaired, and the wire rope removed. The mooring is satisfactory for continued fleet use and is in good condition.
